Open eVision

Inspecting a PCB

1. Inspecting a PCB

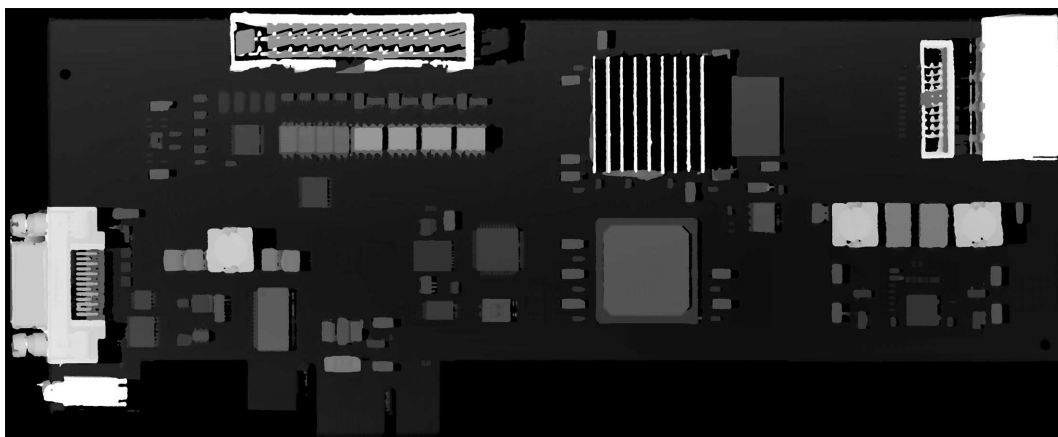
The source depth map of a PCB, outputs of CoaxLink Quad 3D-LLE

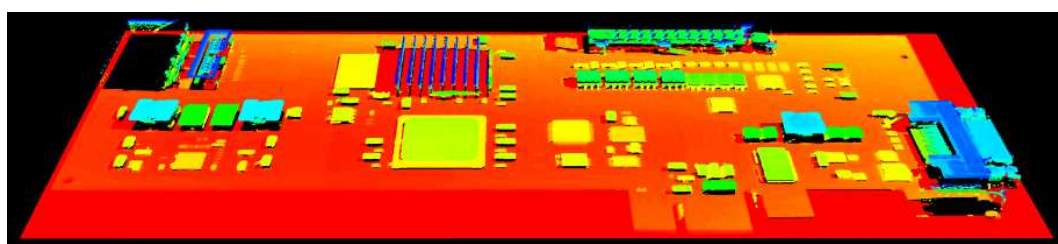
The same depth map displayed as a 3D point cloud with false colors

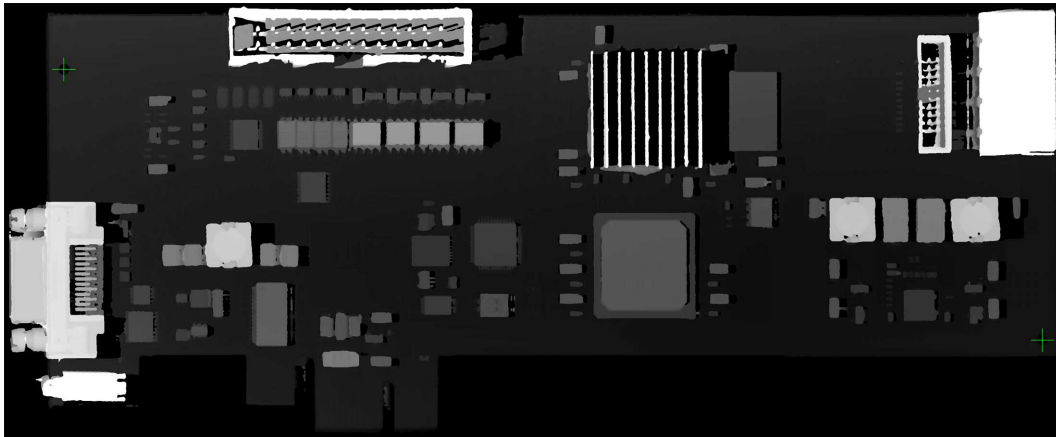
Align the image using fiducial markers (2 holes)

1. Perform a 3D acquisition or create the depth map with software laser line extraction (ELaserLineExtractor class). Retrieve the grayscale image corresponding to the depth map (EDepthMapROI8.AsEImageBW8() method).
2. Align the image using fiducial markers (EMatcher class).
3. Search for the PCB plane and subtract it from the aligned image, only the components and the connectors remain (EasyImage::Oper(EArithmeticLogicOperation_Subtract...) function).
4. Compare the processed image to a golden sample to detect missing or misplaced components (EasyImage::Oper(EArithmeticLogicOperation_Compare...) or EChecker).

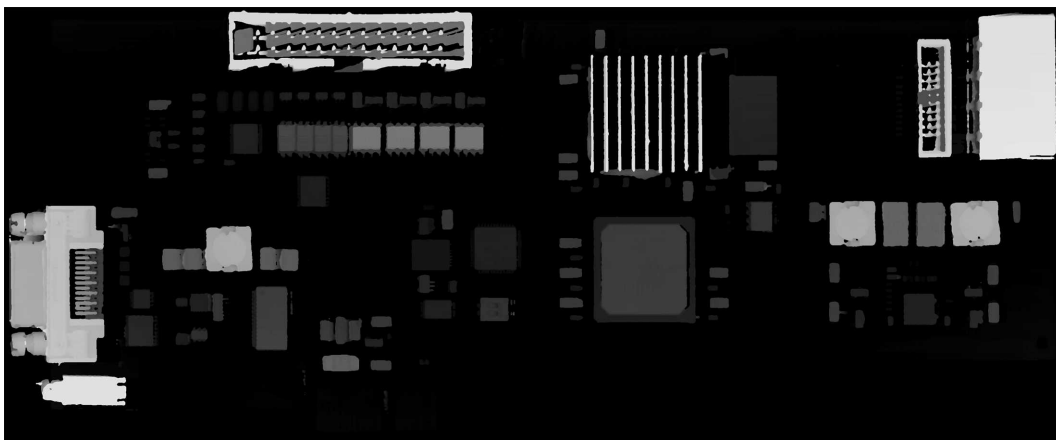
The image with reference plane subtracted, leaving only the components

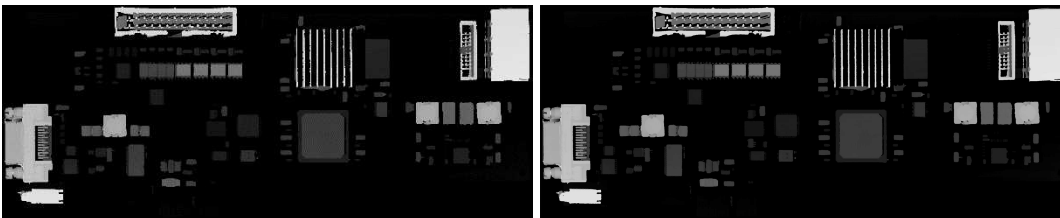
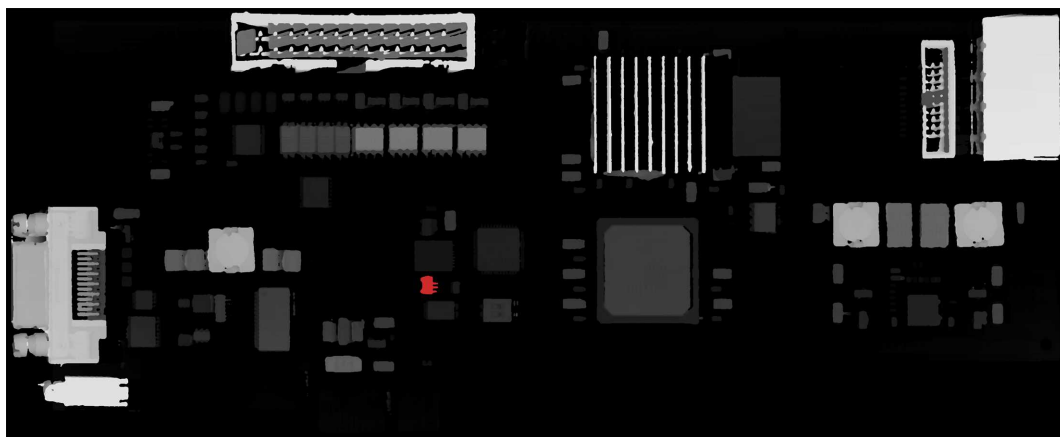
The comparison of the image (left) with the golden sample (right, processed with the same workflow) shows the missing component (in red)
